### ELECTRICAL SAFETY — STRATEGIC SOLUTIONS 2 ENGR. HIPOLITO A. LEONCIO

## ELECTRICAL INSPECTION STRATEGY AND GUIDE

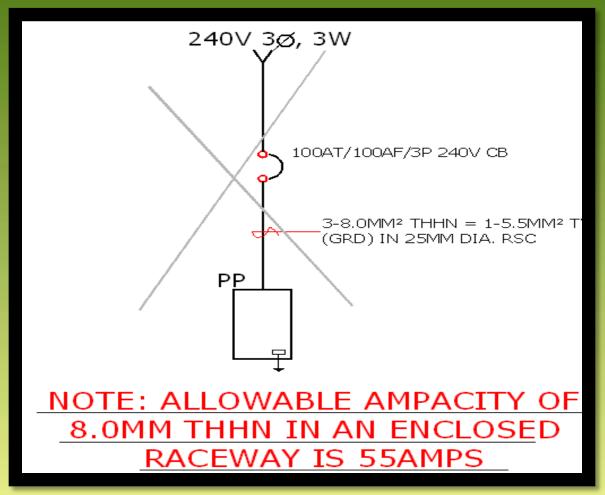
### 1. THE USE OF HIGHER RATED CIRCUIT PROTECTION . . . THIS IS A RAMPANT VIOLATION!

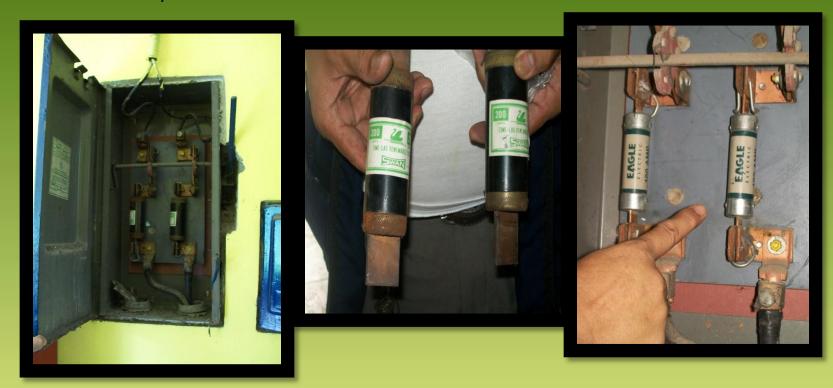
#### 1-A. ANOTHER CASE OF USING VERY HIGH RATING OF PROTECTION...

AS INSPECTED IN 2011, THE SIZE OF THIS SERVICE ENTRANCE FEEDER IS 2 – 14 SQUARE MM IN A PVC CONDUIT, SO THAT THE ALLOWABLE AMPACITY IS 70 AMPERES BUT THE PROTECTION IS 200-AMPERE FUSES!

THE IIEE ESC/ESEA VOLUNTEER TEAM IN 2012 REPLACED IT WITH 100-AMPERE FUSES.

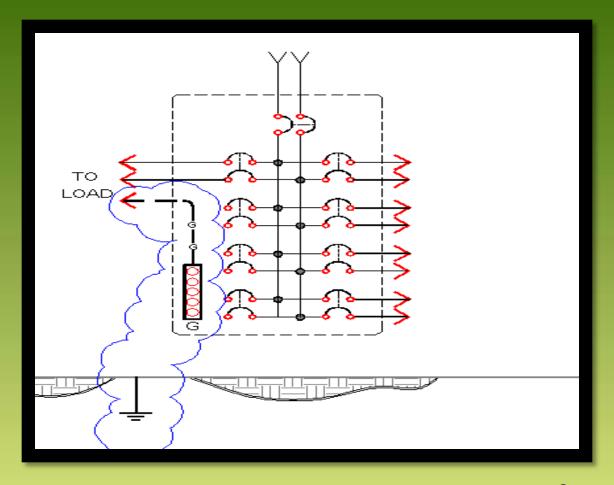
#### 2. INADEQUATE EQUIPMENT GROUNDING . .

WHAT WOULD BE THE MAXIMUM GROUNDING RESISTANCE? IS IT 25 OHMS?5 OHMS?1 OHM? THE LOWER THE VALUE, THE SAFER! WHY? GROUND FAULT CURRENT SEEKS THE PATH OF LOWER RESISTANCE.

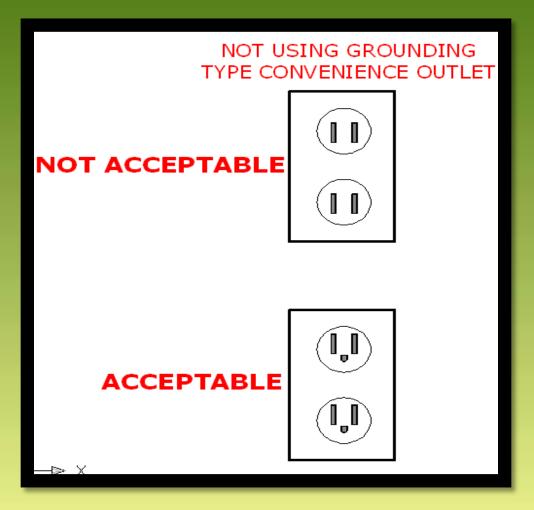
### 3. NOT USING GROUNDING TYPE CONVENIENCE OUTLETS . . .

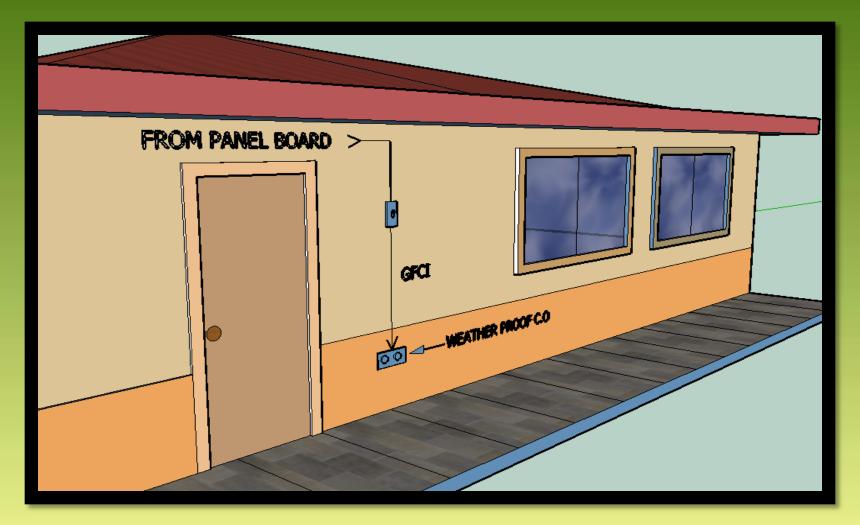
### 4. NOT USING GFCI DEVICE FOR CIRCUITS IN DAMP LOCATIONS OR EXTERIOR AREAS . .

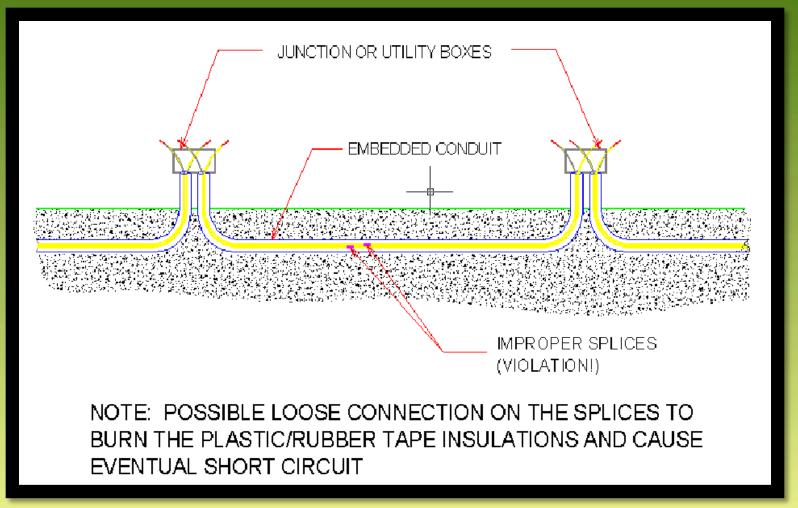
#### 7. USING IMPROPER SPLICES

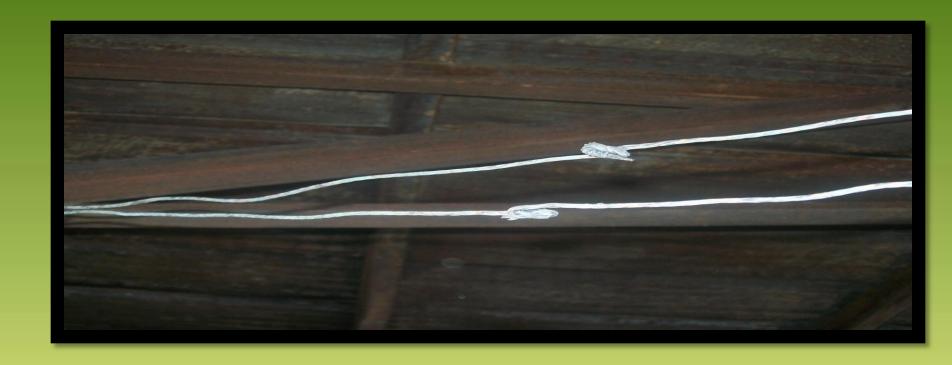
#### 9. LACK OF SUPERVISION DURING CONSTRUCTION...

THESE INAPPROPRIATELY/POORLY SPLICED WIRES INSIDE A BADLY BURNT FLEXIBLE PVC CONDUIT. THE ELECTRICAL SUPERVISOR/FOREMAN MISSED THIS.

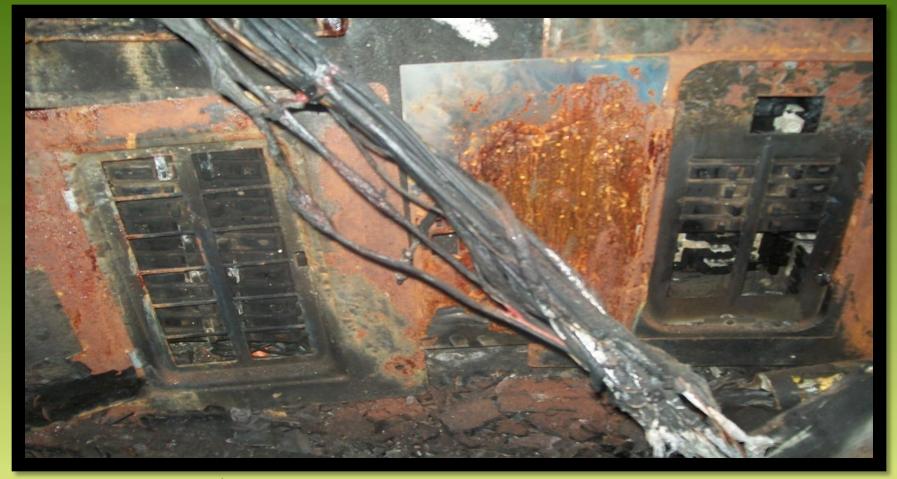
## 10. TEMPORARY WIRING ALLOWED TO BECOME TEMPORARY-PERMANENT

THE FLYING WIRES/CABLES WHICH INCLUDE POWER & COMMUNICA-TION LINES ARE INSTALLED TEMPORARILY.. UNTIL AN UNTOWARD INCIDENT HAPPEN AGGRAVATING MATTERS – ACCIDENTS.

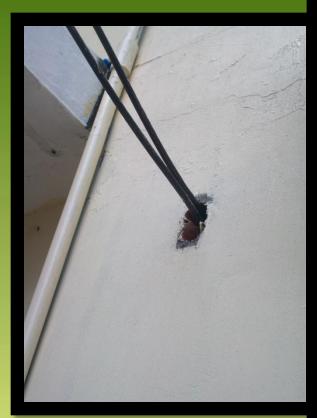
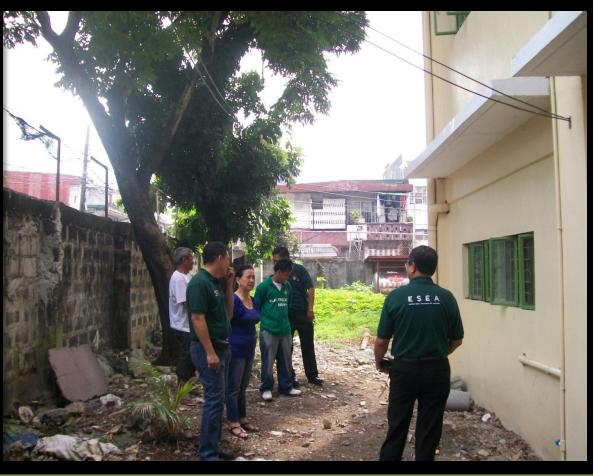
## 12.LACK OF SAFETY SENSE...

NOTICE THE SERVICE ENTRANCE WIRES, NO ENTRANCE CAP OR DRIP LOOP – THIS ALLOWS WATER TO ENTER CONDUIT AND MAY EVEN REACH PANELBOARD INSIDE, CAUSE DAMAGE, OR GROUND FAULT. THERE IS ALSO NO GROUND WIRE.

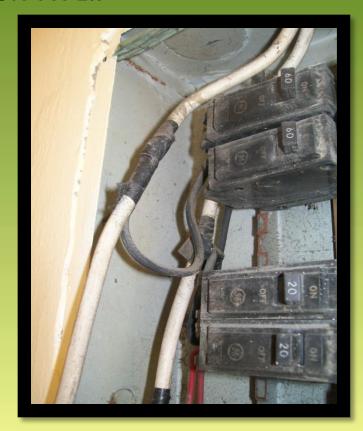
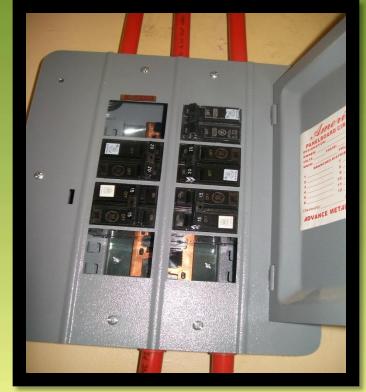
## 13.NOT USING BOLT-ON TYPE MAINS

THE 60A PANEL MAIN CBs ARE PLUG-IN TYPE, SHOULD BE BOLT-ON TYPE..

THE PLUG-IN MAINS WILL RESULT TO LOOSE CONNECTION, LOCALIZE HEATING..

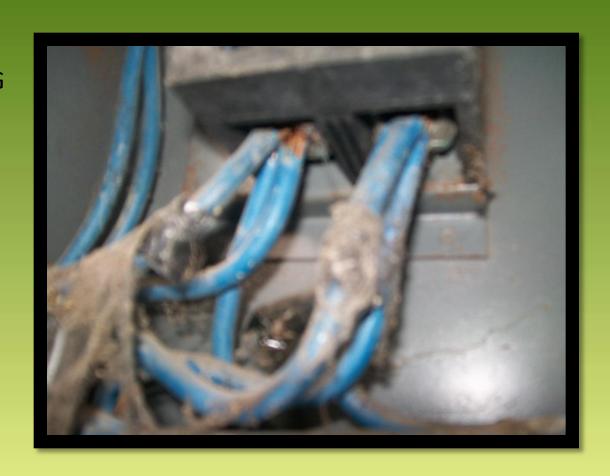
## 14. LACK OF MAINTENANCE

REGULAR CLEANING REQUIRED.

CABLE
TERMINATIONS
ARE VIOLATIONS.

COLOR CODING OF WIRES MUST BE FOLLOWED.

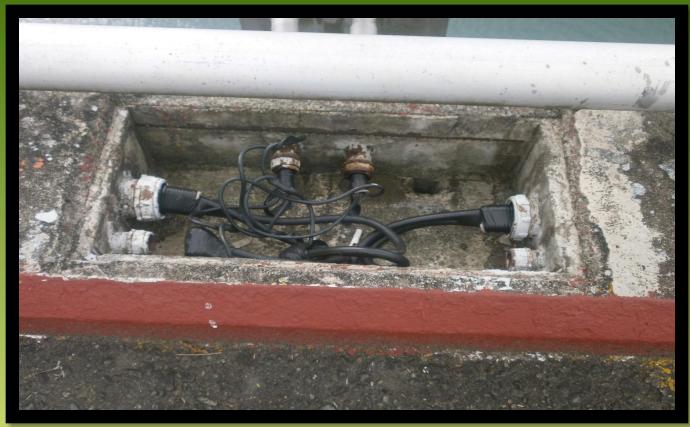
### 15. JUNCTION BOX COVER MISSING ...

THE ABSENCE OF THE COVER FOR THE JUNCTION BOX EXPOSES THE CONDUCTORS NOT ONLY TO WATER BUT ALSO TO THE ULTRA-VIOLET (UV) RAYS OF THE SUN, CAUSING THE DETERIORATION OF THE INSULATION OF THE CONDUCTORS FASTER.

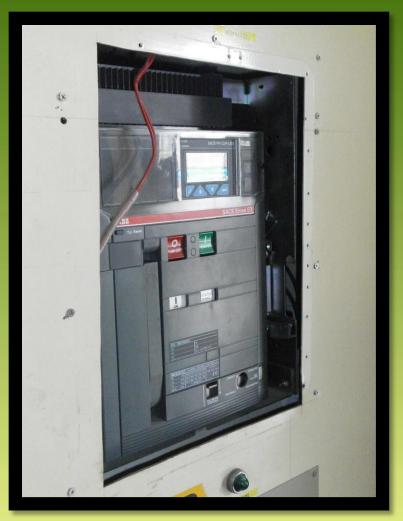
#### 16. Panel Cover & Power CBs Not Fitted Properly...

In a big manufacturing plant, during the retrofitting or replacement of the main circuit breaker of the Low Voltage Switchgear, the panel opening is so big where in there is a large clearance between the front face of new power breaker and the panel opening. This may allow foreign bodies such as dust, and even live creatures to possibly enter inside the switchgear and cause a shutdown. A control wire is even left not tied properly.

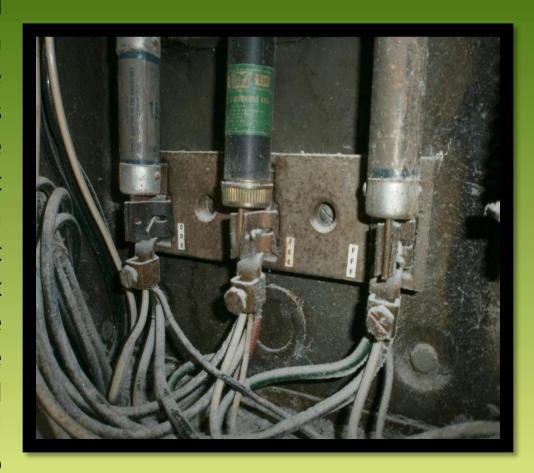
#### 17. Old Fused Disconnects Still in Use?

The use of **old fused** disconnect switches where in the load side feeder wires are too small in their ampacities as matched to the rating of the fuses. The fuses may protect the small wires from high magnitude short circuit current but not on an overload current or during a low magnitude line-to-ground fault. These installations must be replaced with bus bar type panel board of power distribution to various load circuits.

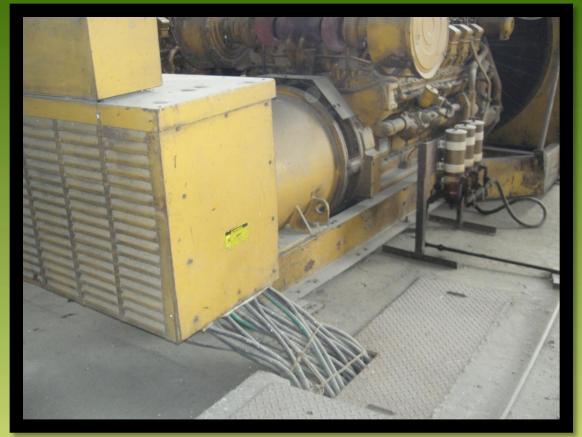
## 18. Cables Not Provided w/ Raceways...

Would you believe that this kind of cable installation still exists? If you are the electrical practitioner assigned to supervise the electrical works, how would you have provided for a better job?By providing flexible metallic conduits? By a cable duct?Or by extending the cable trench?
